Hulihe'e Palace – Assessment of Earthquake Damage 23 October 2006

Page 7 of 7 Hulihe'e Palace – Earthquake Damage Assessment Report 23 October 2006

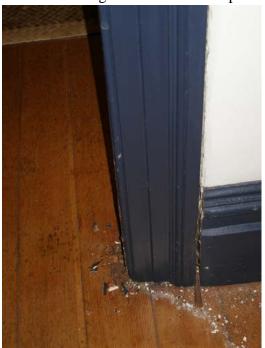
The building movement caused a lot of movement in the woodwork in the Palace, causing some of the original wood to be displaced, and in some cases, cracked.

- Remove selected areas of interior flat plaster, adjust furring if required, and install new plaster. Patch all small cracks.
- Make repairs to miscellaneous wood work items. In many cases this will involve carefully taking apart the wood window surrounds, repairing wood items and

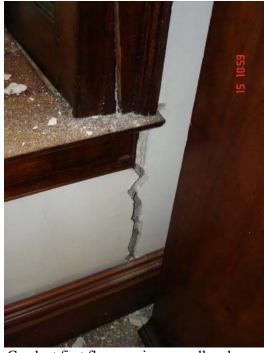
Crack at first floor carries up wall and through the window casing trim. This is an example of a window that will need to be taken apart and reconstructed.

reinstalling the trims. Each step of this process should be carefully monitored and recorded.
